DEBRIEFING

INADVERTENT DISCHARGE OF FIRE BOTTLE (16 Dec 03 - Occurrence #114439)

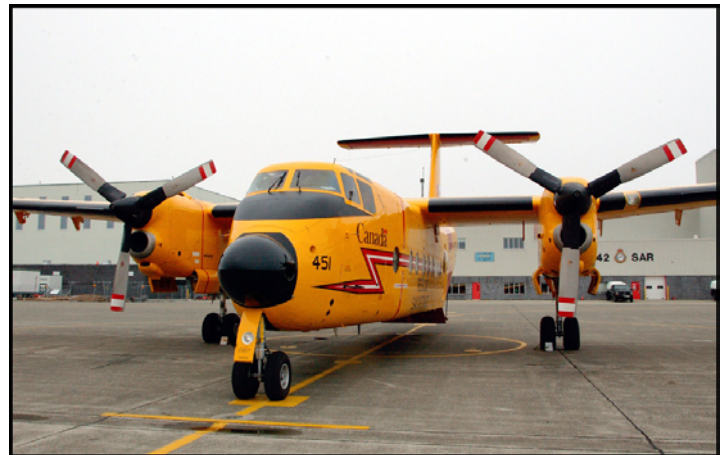
cian entered the aircraft, sat in the right hand seat, and proceeded to pull the right hand feather button with his left hand. The technician was looking out the right window towards the engine when his hand slipped off the underside of the feather button and inadvertently grabbed the fire handle, causing fire bottle to discharge.

The Cause Factor assigned for this incident was Personnel Inattention in that the technician's attention was not focused on the proper switch selection. As a preventative measure, the maintenance personnel were briefed on the importance of maintaining situational awareness at all when operating any aircraft controls.

Following the discharge, all aircraft power was turned off, the aircraft was vacated, and the hangar doors were opened to dissipate any discharged gas. The three technicians who were located under the right hand nacelle at the time of the discharge were sent to the local hospital and subsequently released. The Wing Environmental Officer was informed and the right hand engine fire bottle was replaced.
